ARCHITECTURAL ASSESSMENT & HISTORY OF THE CITY HALL OF BAKER CITY

BAKER CITY CITY HALL RENOVATION PROJECT
BAKER CITY, OREGON

ARCHITECTURAL CONSERVATION
ASSESSMENT REPORT

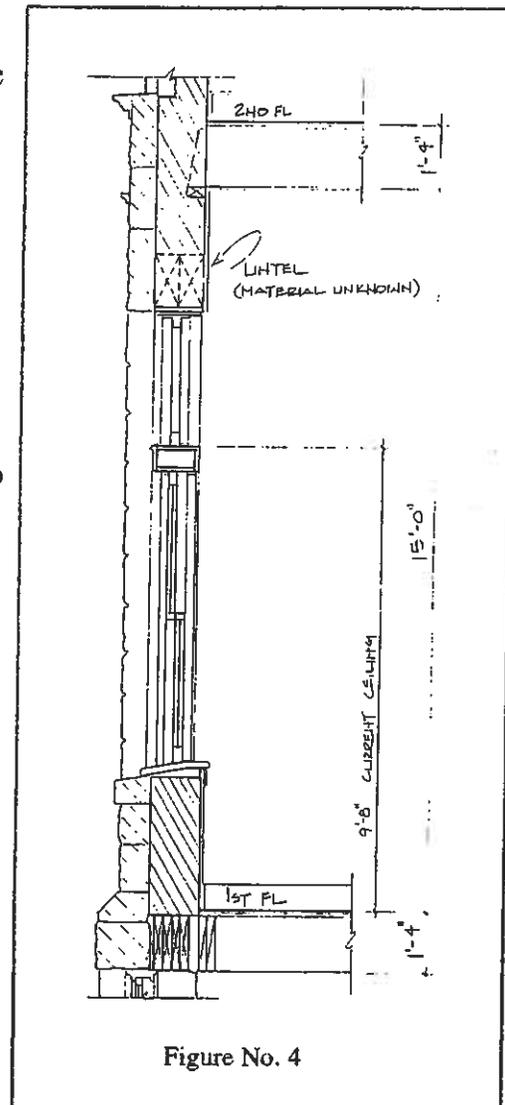
Figure No. 4

The exterior wall narrows at the first floor level to nineteen inches with the inset of a five inch water table course (See Figure No. 4). Water table courses were a design element to visually note a floor level, while trying to provide a physical element to direct water away from the base of the building. The size of brick, as observed on the interior of the tower, is roughly four (4) inches wide and eight and one-half (8 1/2") long. A wall three bricks thick would measure in the vicinity of 13" to 14". This would allow for a 4 to 5 inch stone veneer plus mortar joint. At the first floor, the joists bear on a wood ledger built into the top of the basement rubble wall. The basement window openings have an interior wooden lintel composed of 4- 2 x 14s. On the exterior, the basement windows have a single stone lintel. Eleven of these lintels are cracked. Shear cracks are present in one of the stone mullions, and numerous cracks can be found in the water table course around the building. Being a long, flat stone, the water table course is highly susceptible to differential building settlement. With the absence of cracks in the walls above, it appears most of the settlement of the building has been taken up in the water table course and the lintels. The water table cracks can merely be repointed, as many have already, but the lintel should be cross-pinned for stability.

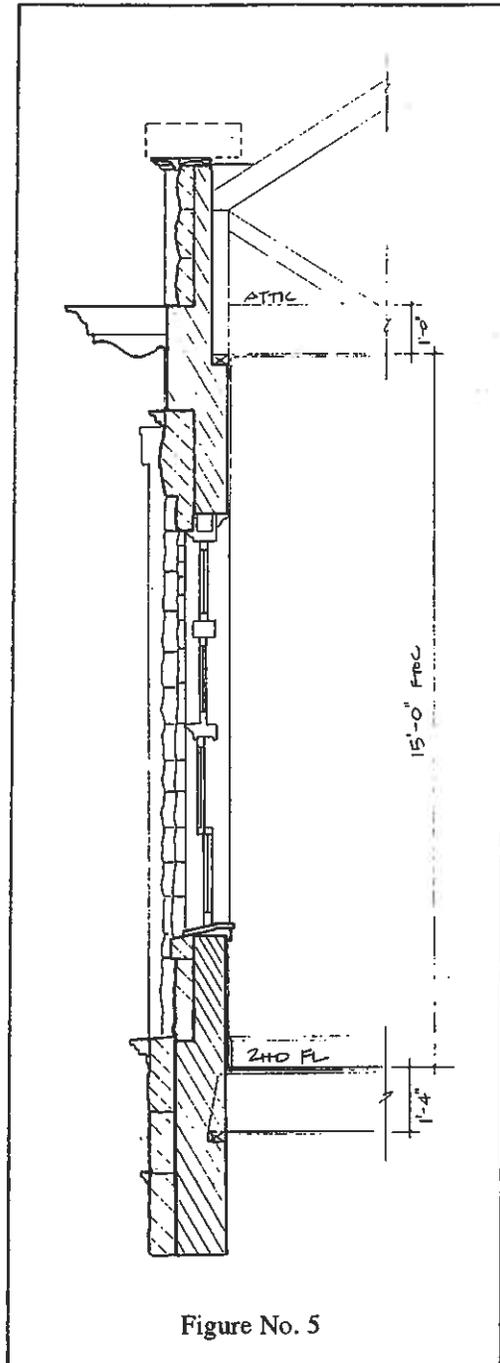
Figure No. 5

Above the second floor, the exterior masonry walls make a number of step-backs, or inset, to high-light the windows and articulate the composition of symmetrical bays (See Figure No.5). The building corners are formed to appear to be engaged columns. The columns are in the same plane as the first floor wall. The columns continue upward past the sheet metal cornice where they once terminated with a capstone. The capstones, which can be seen in early photographs of City Hall, were probably removed during roofing repairs. Away from the corners, the wall steps back three (3) inches across the face of the wall. Each window is further recessed three (3) inches within a nine (9) inch archway. Both the inner archway, and the arch over the window, are primarily composed of

stone. Along the haunches of the arch, the individual archstones are squared to align with the regular coursing of the stone veneer. The brick interior portion of the wall appears to reduce to nine (9) inches along the second floor, with the possible exception of at the corners and behind the metal cornice. Behind the stone arch of the windows, the brick is also expected to be arched. The large galvanized metal cornice at the attic level would be expected to be supported from a wooden framework anchored into masonry pockets along the run of the cornice. The metal is merely anchored to the wooden framework by nails or screws. Details like the brackets, or modillions, would be soldered to the main cornice body. It was common to sandpaint such a cornice in imitation of stone.

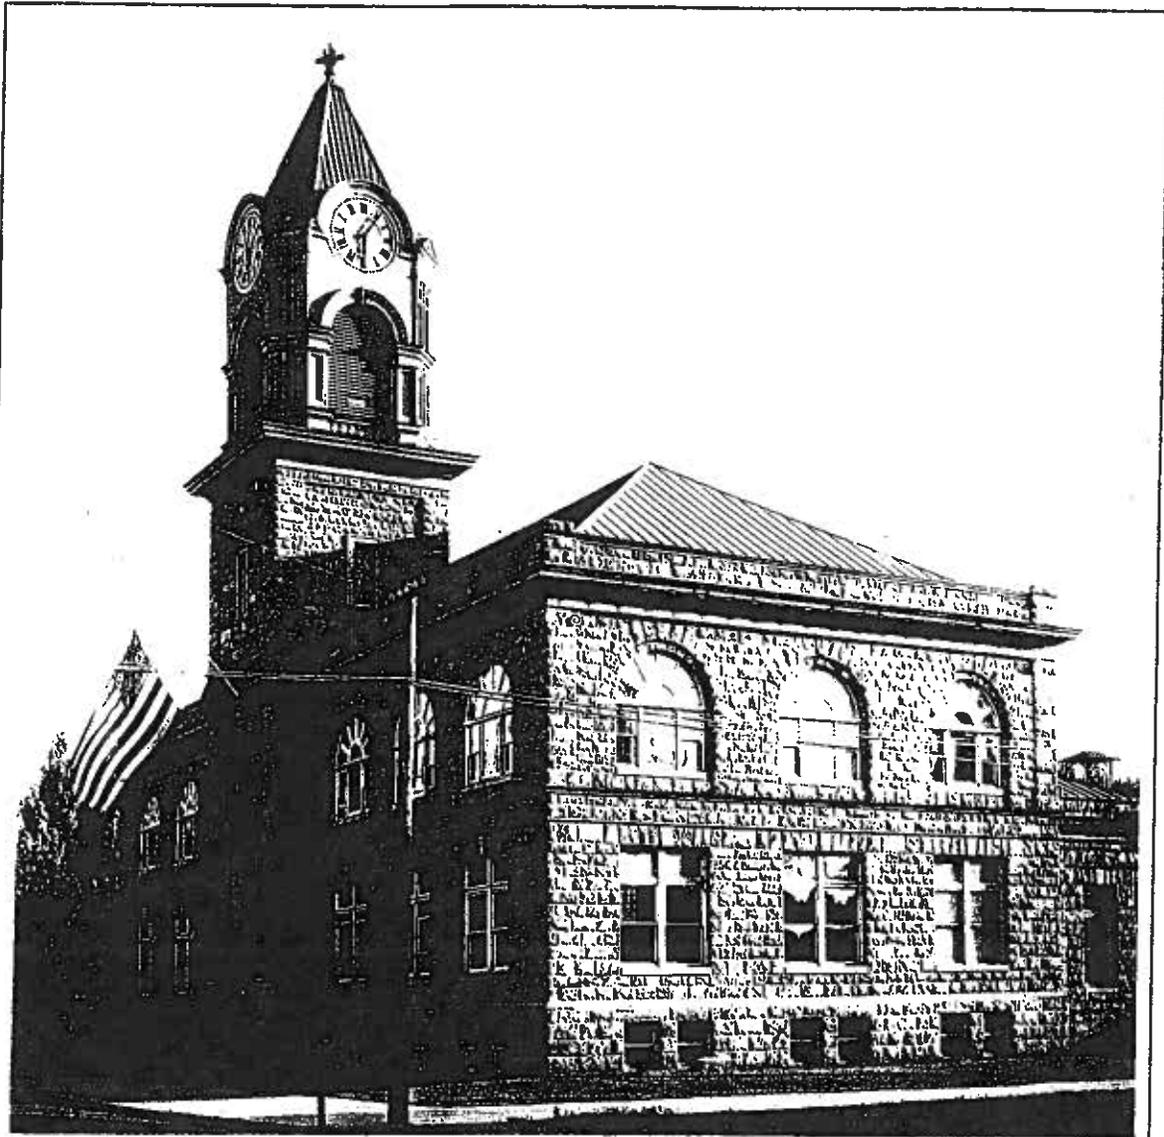
Figure No. 7

Following a formal system of symmetrically balanced bays on the building's elevations, the windows progress upward in a hierarchy of detail and design (See Figure No 7). The basement bay has small double hung wood windows with a central stone mullion. Most of the windows are original. Four units in the southwest corner have been replaced with new insulated windows closely resembling the original. The extant windows are in fair condition, requiring a moderate level of rehabilitation.

The first floor window bays are rectangular in shape, and originally supported a pair of wooden double hung windows with matching transoms. These have been altered by replacement of the double-hung portion with fixed framed aluminium windows. A metal pan covers the original

transom windows which still are extant. Where accessible, the transoms have a natural wood finish on the interior and appear to be in good condition.

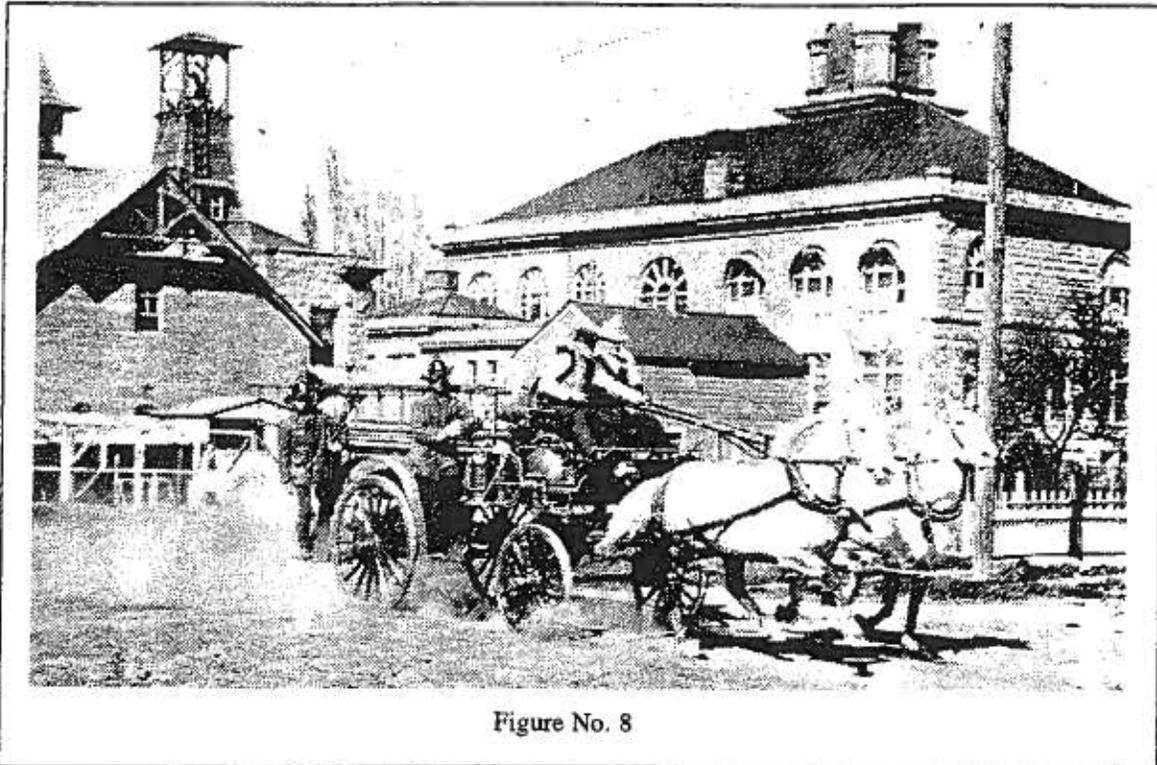
Figure No. 8

The original wooden sash of the main staircase window of the west elevation has been replaced with fixed aluminum frames. The primary mullion and transom frame are still present, though covered on the exterior with aluminum panning. A historic photograph indicates this window was similar in design to the rest of those on the second floor (See Figure No. 8) While the interior of the primary mullions appears in good condition, the presence of aluminium panning on the exterior suggests some deterioration. This window will require extensive rebuilding and replacement for rehabilitation.

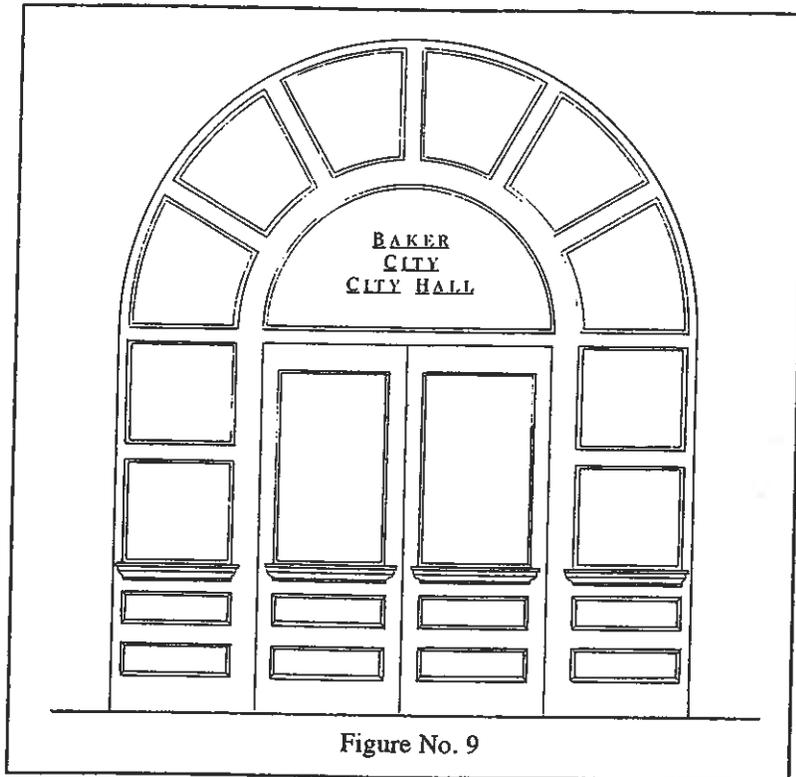
Figure No. 9

The main entry doors currently are aluminium store front glass doors with integral sidelights. To fill out the arched opening, the original arched wooden mullioned transom is still present. The date of the removal of the original entry assembly is unknown. Based on the date and style of City Hall, the original design would have consisted of a pair of wooden panelled doors with glass panels. The sidelights would have

been expected to continue the rhythm of the mullion from the arch (See Figure No. 9) Protected within the alcove of the entry, the existing arched portion of the original assembly is in good condition. The missing section will require a complete rebuild.

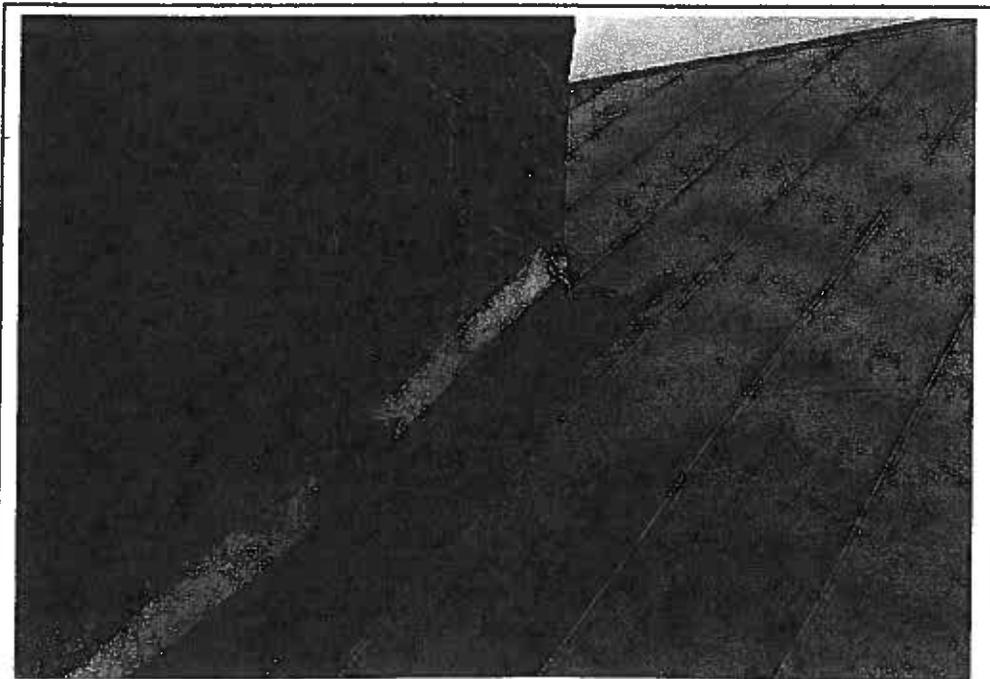
Figure No. 10

The wood frame roof of City Hall supports a standing seam, terneplate roof. Terneplate was a common roofing material at the turn-of-the-century. It was installed in small, 24" wide sheets (See Figure No. 10). It consists of iron or steel sheets coated with a lead-tin alloy. It is a lightweight, strong roofing material which is still being manufactured today. While it has a small rate of thermal expansion, design details require careful attention to insure long-term performance.

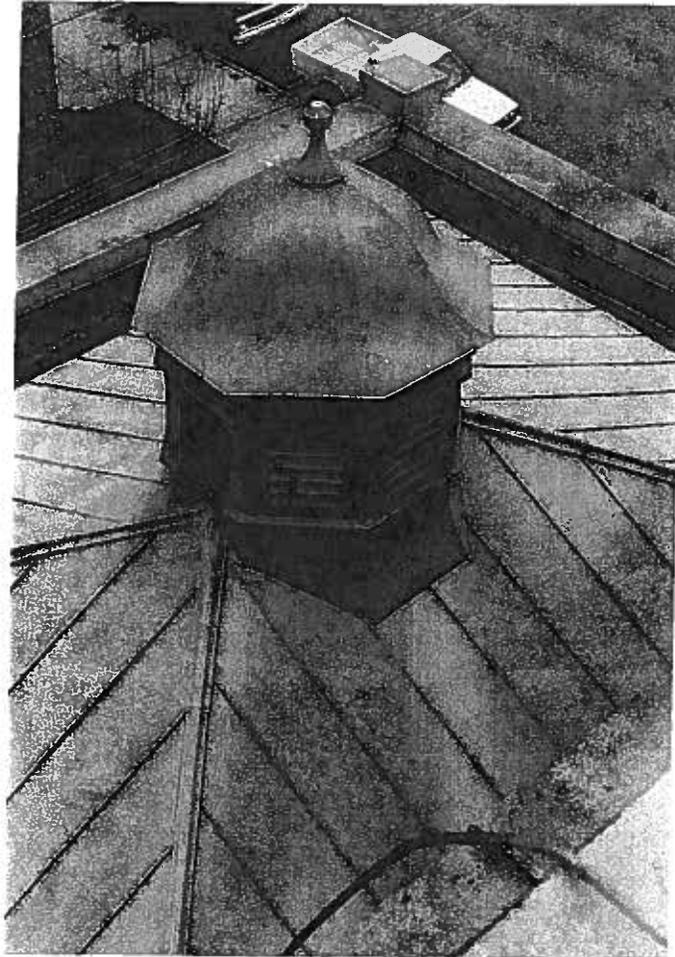
Figure No. 15

The early portion of the jail annex has a standing seam pyramid roof with a lovely central octagonal ventilator (See Figure No 15). Similar to the main roof, the standing seam areas have been coated with an asphaltic compound. The gutters have been overlaid with what appears to be a single-ply, synthetic rubber sheeting. Originally there were two downspouts, one in the northeast corner and one in the southwest corner. On the day of field inspection, standing water was over the northeast downspout indicating restricted drainage or that the drainline is completely plugged. The original southwest downspout has been abandon to allow roof connection to the rear portion of the annex. The roof appears to be in fair condition for the moment, but the presence of the asphalt on the original terneplate

suggests some problems have been covered over with an increased potential for failure.

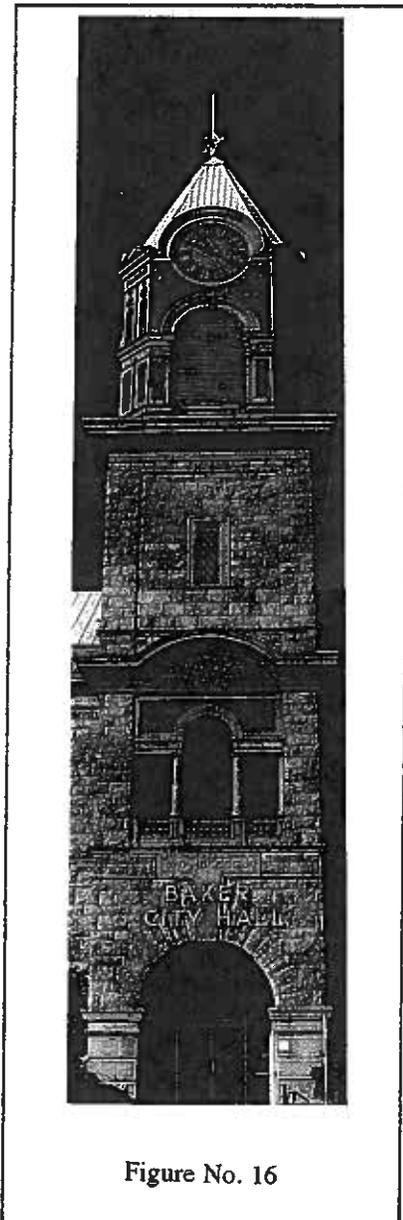
Figure No. 16

Above the masonry portion of the central tower, the heavy timber frame of the bell loft supports an extensively articulated exterior galvanized metal facade which defines and emphasizes the four clock faces (See Figure No. 16). While the paint coating is in poor condition, the metal itself looks to be serviceable with the possible exception of two twisted sections on the north elevation. These twisted sections may have just been installed that way, or represent some alteration within the wooden support frame. Closer investigation will be required.

An exterior Palladian porch is enclosed within a portion of the second floor level of the tower (See Figure No. 16). The porch is wood frame and clad in painted, galvanized metal of decorative form. The exposed porch floor is flat seamed terneplate. The roof has a base flashing nailed to the masonry side walls and rear framed wall. Only at the juncture with the base of the front balustrade is there a counter flashing. A single drain hole is present in the north, central areas of the roof. The upper portions of the north and south walls have peeling paint from moisture penetration of the tower roof.

Though suffering extensive paint failure, the porch metal appears in fair to good condition. A few soldered mitres at the corners of decorative elements have come open. These should be cleaned and resoldered. A number of sheet metal screws penetrate the assembly from past attachments and should be removed with the holes plugged. Extensive preparations will be needed in the repainting process. Counter flashings should be installed where absent.

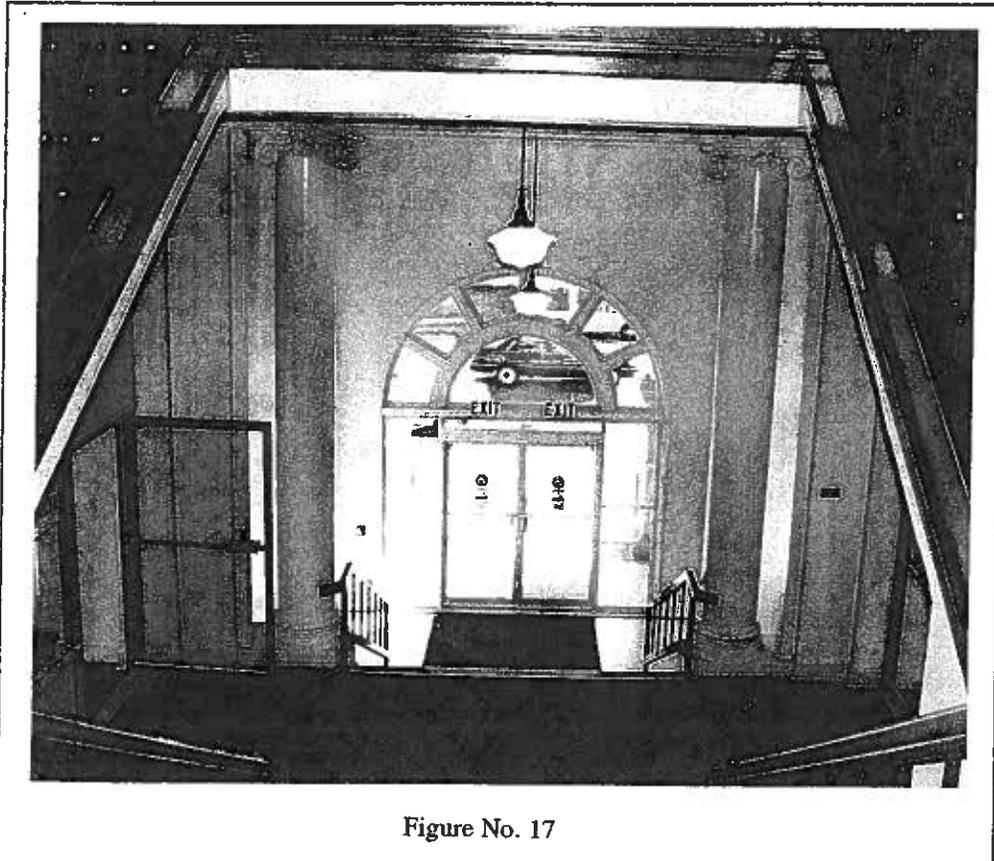
Figure No. 17

Several pieces of the landing tile are missing. Almost 25% of the border tile is gone. There is a large crack running through the center of the landing, presumably from the settlement of the tower. The walls and ceiling of the landing, including the coffered beam and columns are in good condition. It is uncertain whether the structural beam within the coffer is steel or wood, as both are used in the building.

The marble steps are a problem. Several marble pieces are extensively cracked. This is due to the thinness of the material. When inspected from underneath, the wooden stair stringers have been fitted with small extensions to accept the marble. The marble steps do not appear to be original, though the marble is a type used extensively in Oregon at this period. Steps of stone are supported on

The present handrails are not original, and need to be replaced with a more compatible design.

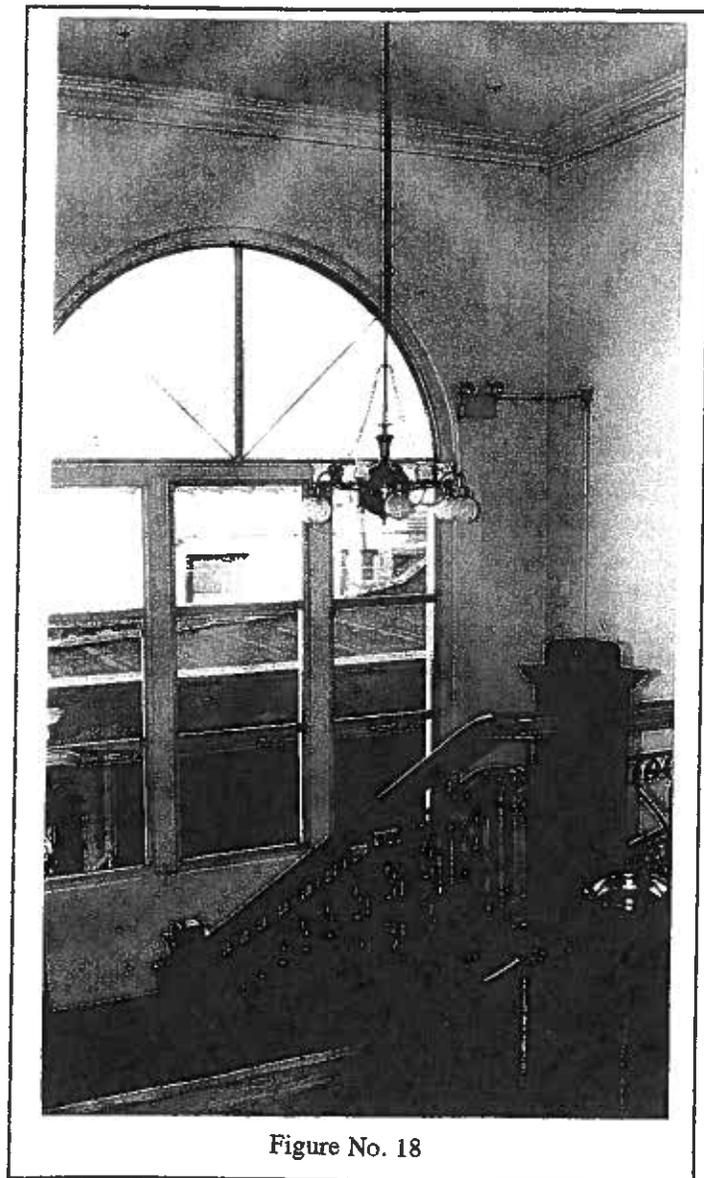
Figure No. 18

The central staircase is wooden. The center portion of each step has been covered with vinyl sheetgoods. The exposed wooden edges are painted red. Each step has a metal nosing strip. The newel post at the intermediate landing and each floor (See Figure No 18) is wood with a dark stain

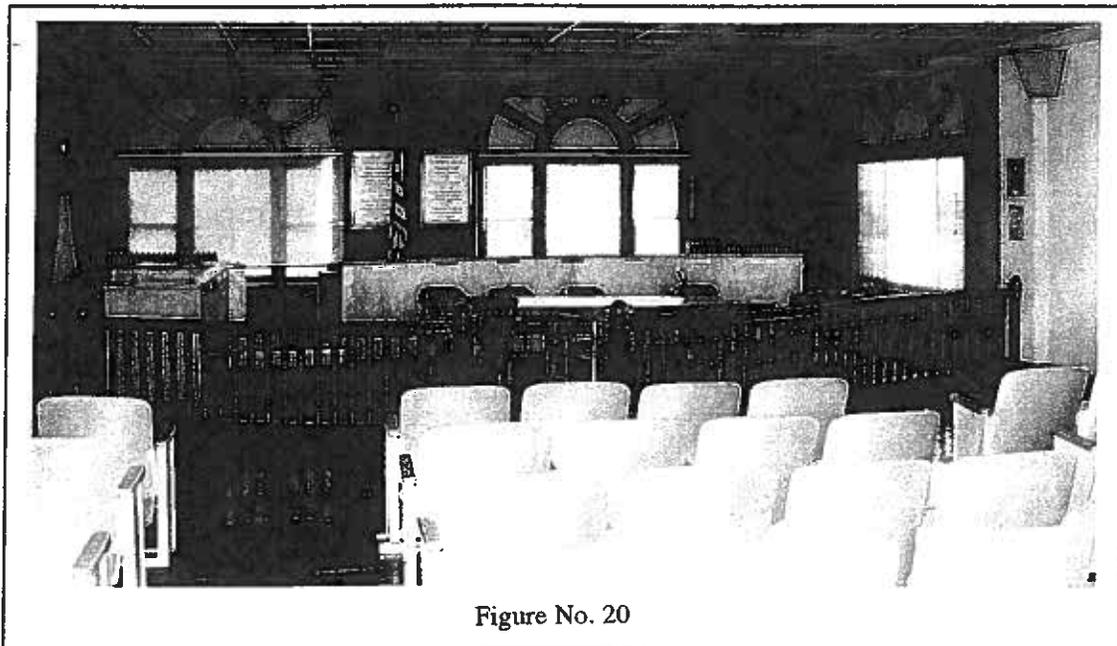
Figure No. 20

The present metal grid, lay-in ceiling system hides the original tri-

part design of the chamber space. At the third points along the long axis of the room, moulded coffer beams resting on classical pilasters are present in the 15' -0" ceiling. The beams encase the lower chord of heavy timber trusses used to support the ceiling joists. The coffer beams, pilasters, walls, ceilings, and base are all plaster finished. Beneath the current rubberized floor sheet is a 2 1/4" unfinished fir floor. The west end of the council chamber has a modern, elevated platform with a counter for council hearings. The presence of an original elevated platform could not be determined. A reverse curved, wooden balustrade with central opening defines the western third of the Council Chambers. The balustrade has a dark mahogany finished stain (See Figure No. 20).
