ARCHITECTURAL ASSESSMENT & HISTORY OF THE CITY HALL OF BAKER CITY

BAKER CITY CITY HALL RENOVATION PROJECT
BAKER CITY, OREGON

ARCHITECTURAL CONSERVATION
ASSESSMENT REPORT

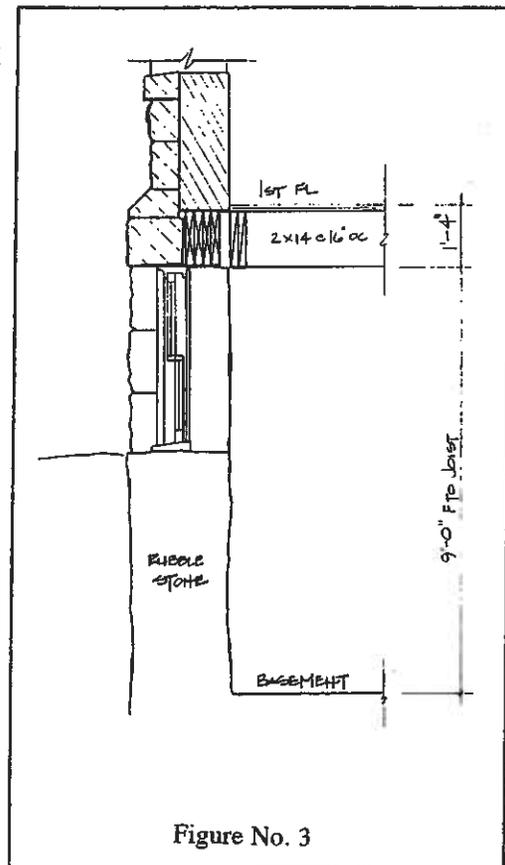
The walls of the basement are two feet thick (2'-0") and composed entirely of stone (See Figure No. 3). The interior is a rubble stone. The veneer goes down to grade. The tradition of this type of structure would be to continue the rubble below grade down to a spread footing made of either single large stones or brick. There are a few cracks near the base of the wall associated with footing settlement. The grade at the base of the building has grown since initial construction. The sill stones of the basement windows, now covered by grade, are pitched face, indicating there were originally exposed. This raised grade condition has created a negative slope against the basement wall in several locations. At the southeast corner of the basement, deterioration of the mortar has been occurring from moisture accumulation. In addition, the close proximity of plants next to the base of the basement wall has most likely led to some other areas of internal mortar disruption. Plants will hold moisture next to their root structure,

and should always be located a good distance away from the base of a building.

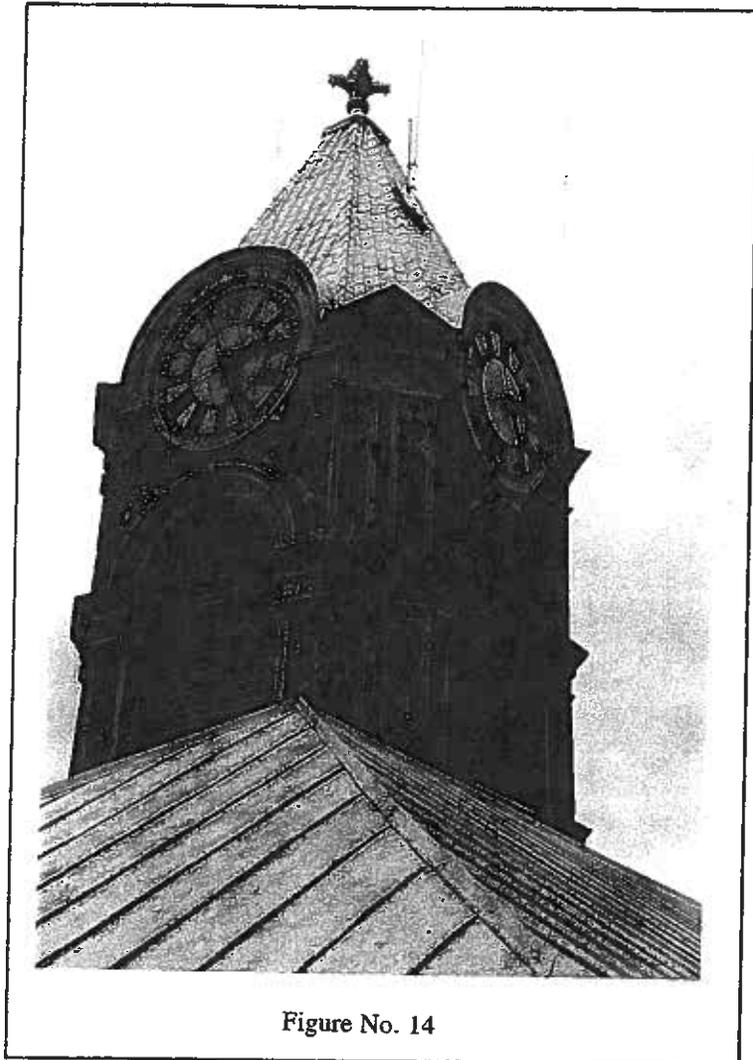
Bell Loft Roof

At the top of the masonry walls of the clock tower, where the structure changes to wood frame, a flat seam terneplate roof is present. The roof is in fair condition. Perimeter flashing are suspect due to moisture stains on the walls below.

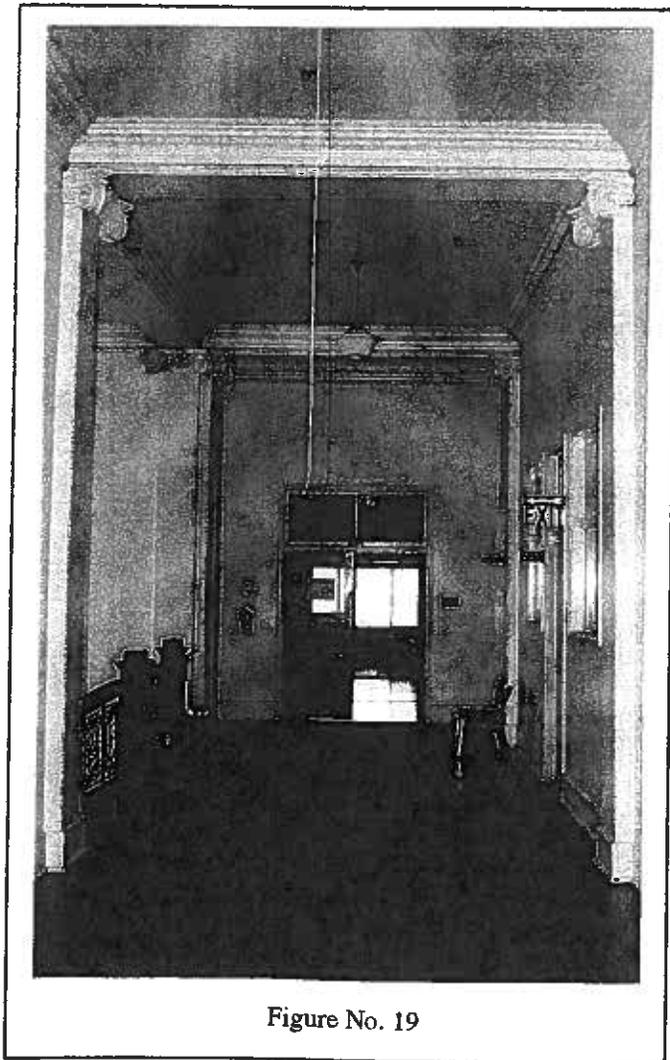
Figure No. 19

At the top of the staircase, a central corridor runs north and south. Retaining its original ceiling height, the plaster walls and ceilings continue the classical style of ceiling mouldings and pilasters with composite capitals (See Figure No. 19). Structural beams are coffered for integration into the moulding. To the south, the corridor provides access to offices on both sides and terminates at a cross partition. Originally the partition was solid, but currently has a new door opening into an existing cross corridor. Off this cross corridor is a small vault. Like the other vaults in the building, it has solid masonry walls, and a concrete floor and
